Manhole Inspection Summary

Manhole # S37A2_014MH

Insp Date: **12/5/07 12:52 PM**

Location Address: **3917 2nd St**

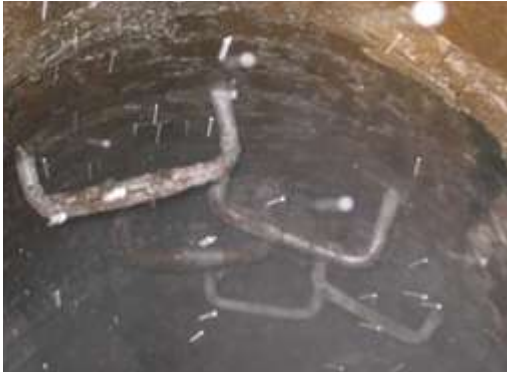
steps

Steps Count: **5** Missing: **0** ☒ **Corroded**

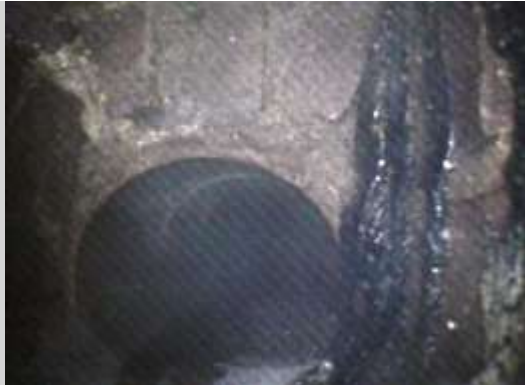
12 O'Clock Outflow

8 in. Circular Gravity Sewer
Pipe Out @ 12 O'Clock

Pipe Height: **8.4** (in.) Rod and Bar (Angled)
Pipe Material: **Clay** ☐ Pipe Lined
Invert Depth: **9.32** (ft.) Flow Characteristics: **Fast**
Deposits: ☒ None ☐ Mud ☐ Sludge ☐ Debris ☐ Grease
Silt Depth: (in.) Deposits Extent:
Infiltration: **None** Pipe Seal Cond: **Sound**

Connects To: **Manhole**

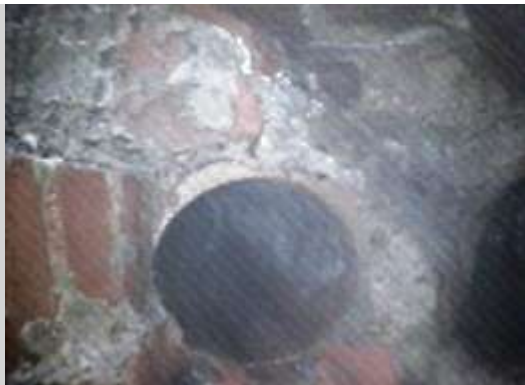
5 O'Clock Inflow

8 in. Circular Service Sewer
Pipe In @ 5 O'Clock

Pipe Height: **7.2** (in.) Rod and Bar (Angled)
Pipe Material: **Clay** ☐ Pipe Lined
Invert Depth: **8.50** (ft.) Flow Characteristics: **Fast**
Deposits: ☒ None ☐ Mud ☐ Sludge ☐ Debris ☐ Grease
Silt Depth: (in.) Deposits Extent:
Infiltration: **None** Pipe Seal Cond: **Sound**

Connects To: **House connection / Service line**

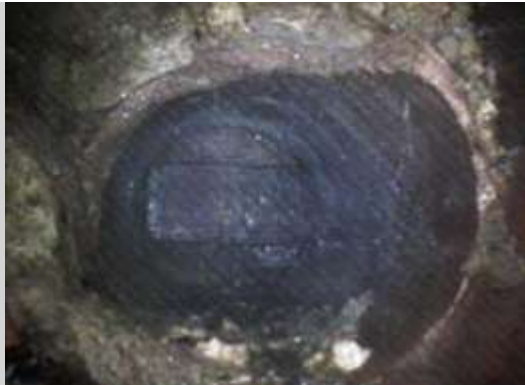
6 O'Clock Inflow

8 in. Circular Service Sewer

Pipe In @ 6 O'Clock

Pipe Height: **7.2** (in.) Rod and Bar (Angled)

Infiltration: **None** Pipe Seal Cond: **Sound**

Connects To: **Stub connection / abandoned**

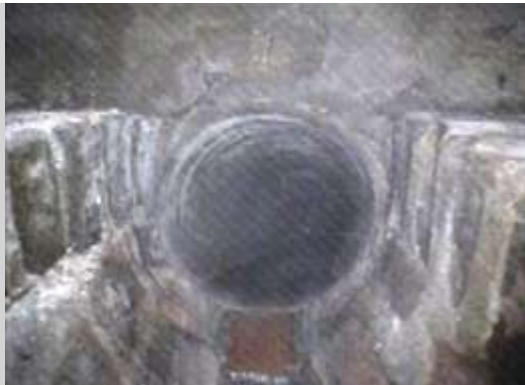
9 O'Clock Inflow

8 in. Circular Gravity Sewer

Pipe In @ 9 O'Clock

Pipe Height: **7.2** (in.) Rod and Bar (Angled)

Infiltration: **None** Pipe Seal Cond: **Sound**

Connects To: **Manhole**
